John F. Kennedy Space Center, FL Hurricane Frances Damage Assessment Photos

John F. Kennedy Space Center Hurricane Frances Damage Assessment Photos

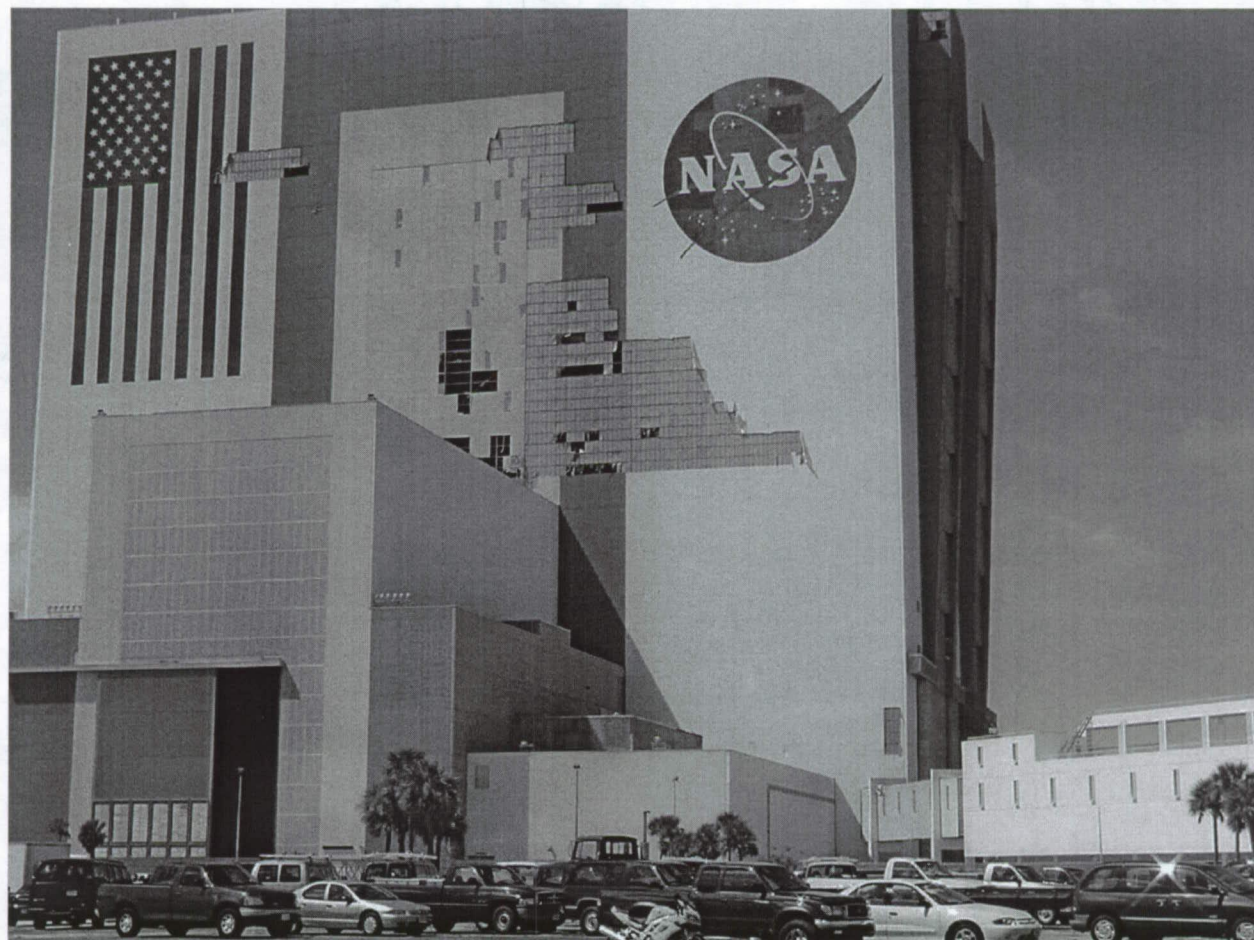
Vehicle Assembly Building (VAB) (K6-0848) – exterior panel damage
(south side)

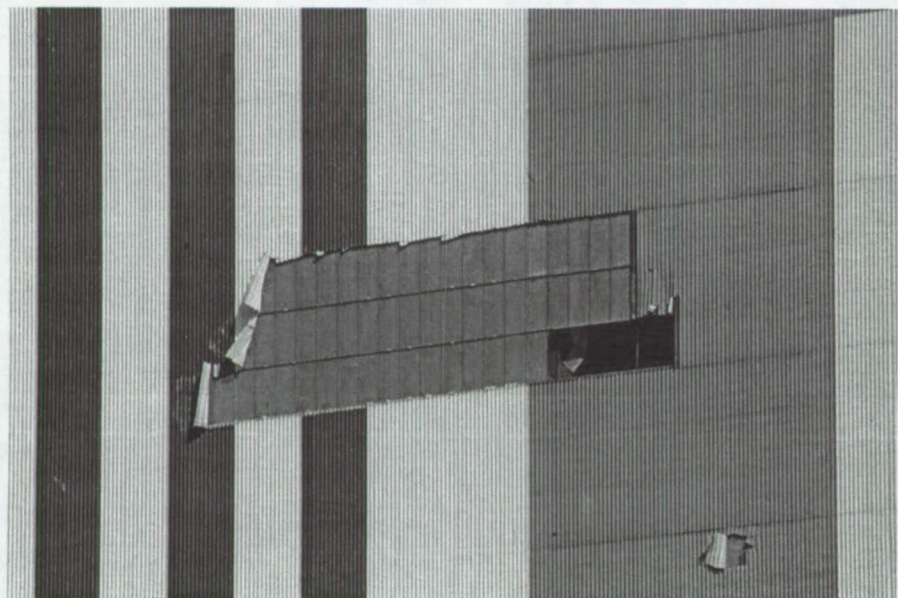
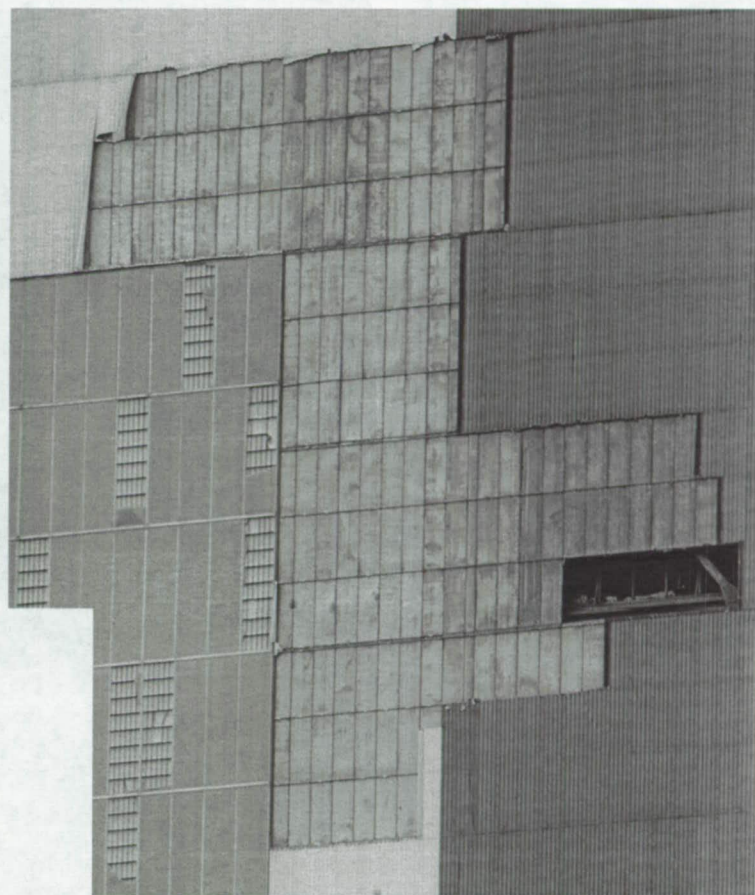
LC39 Area:

Vehicle Assembly Building (VAB) (K6-0848) – side panel damage above low bay south side

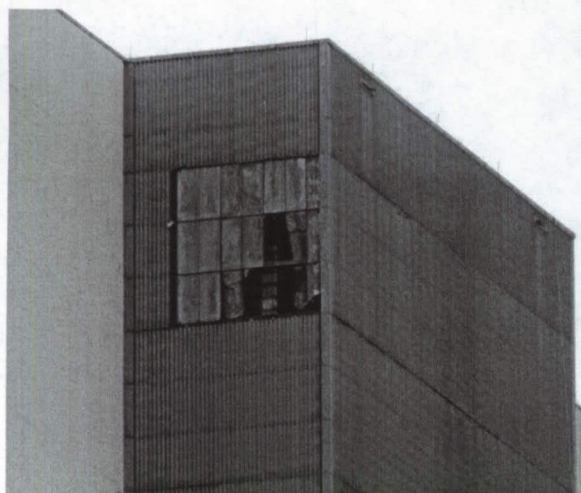
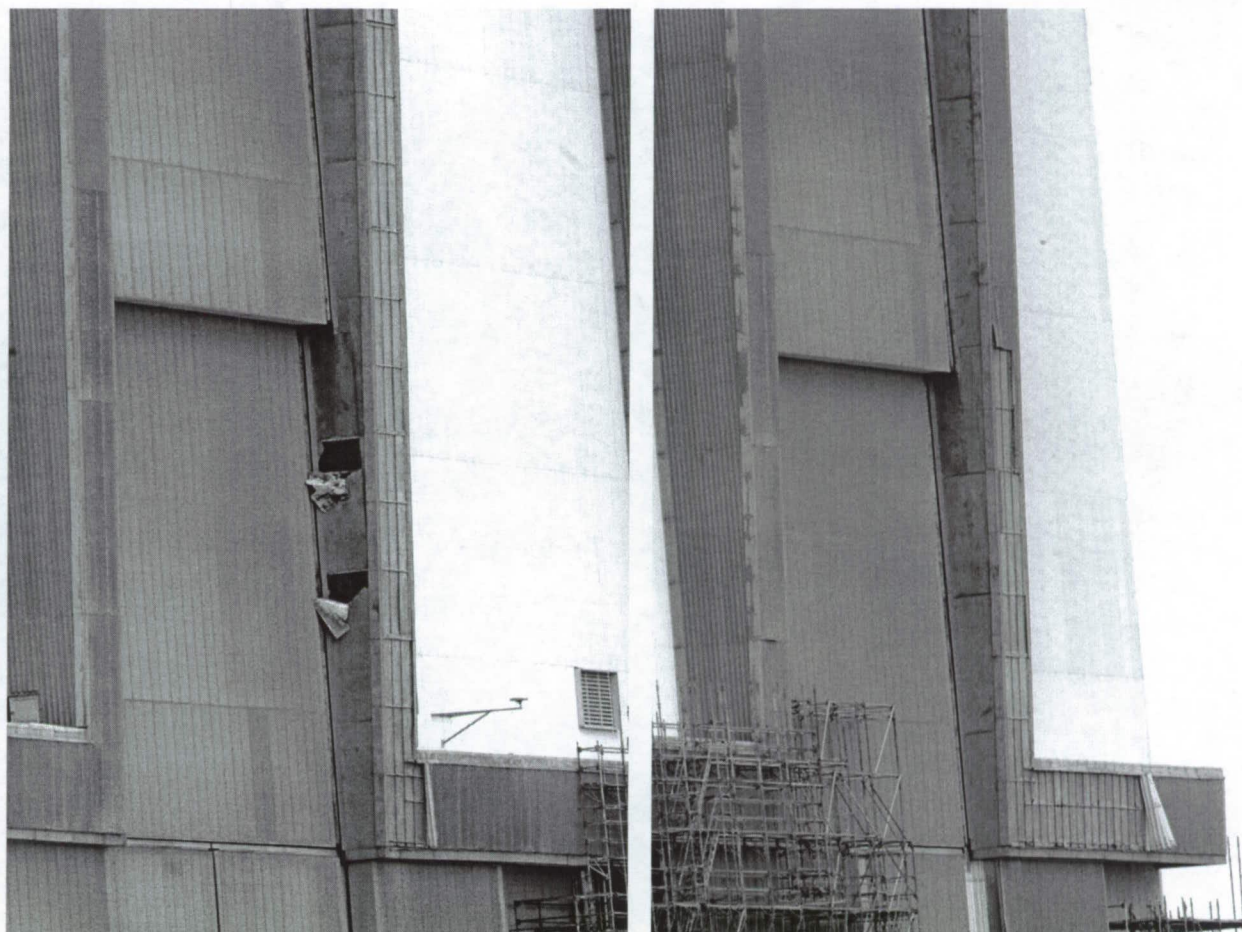
LC39 Area:

Vehicle Assembly Building (VAB) (K6-0848) – panels near east side doors damage

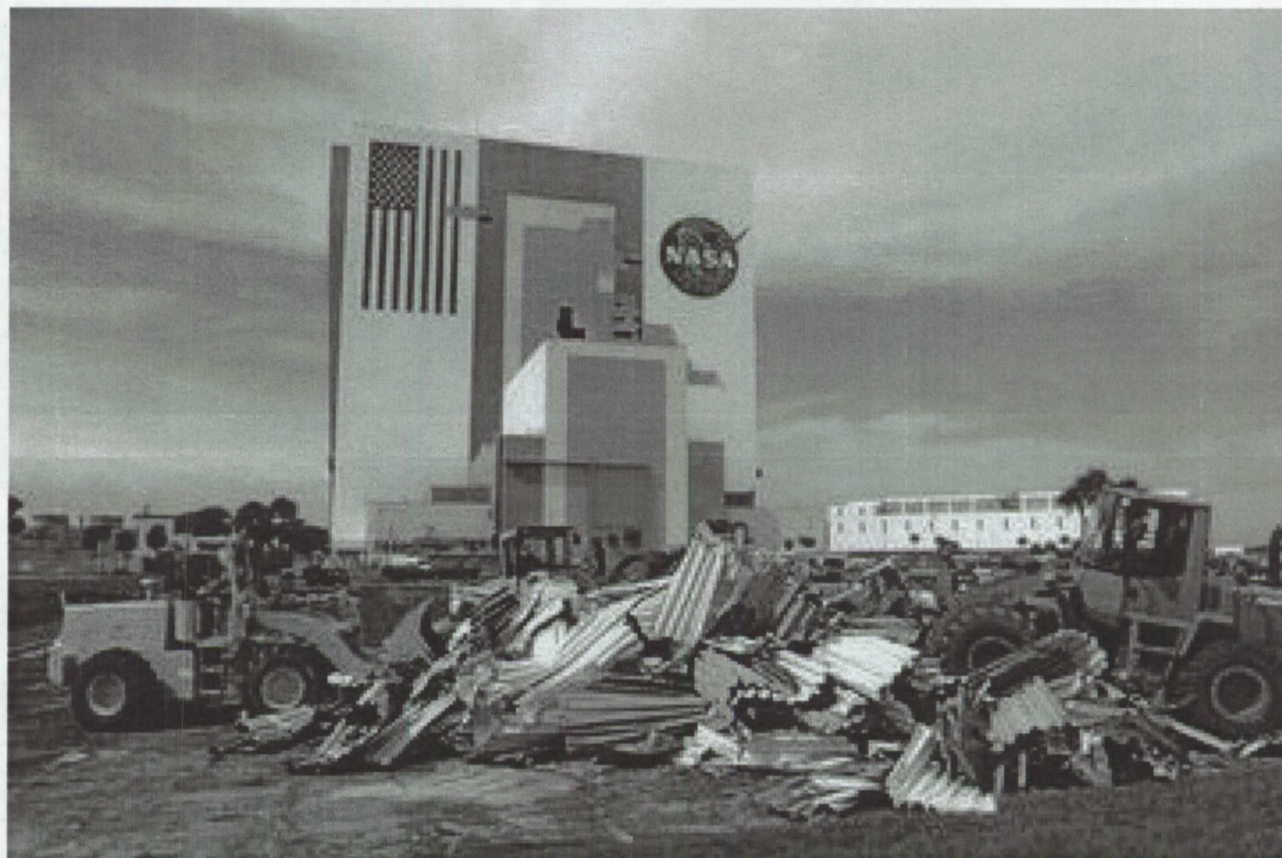
Vehicle Assembly Building (VAB) (K6-0848) – debris pile from exterior panels

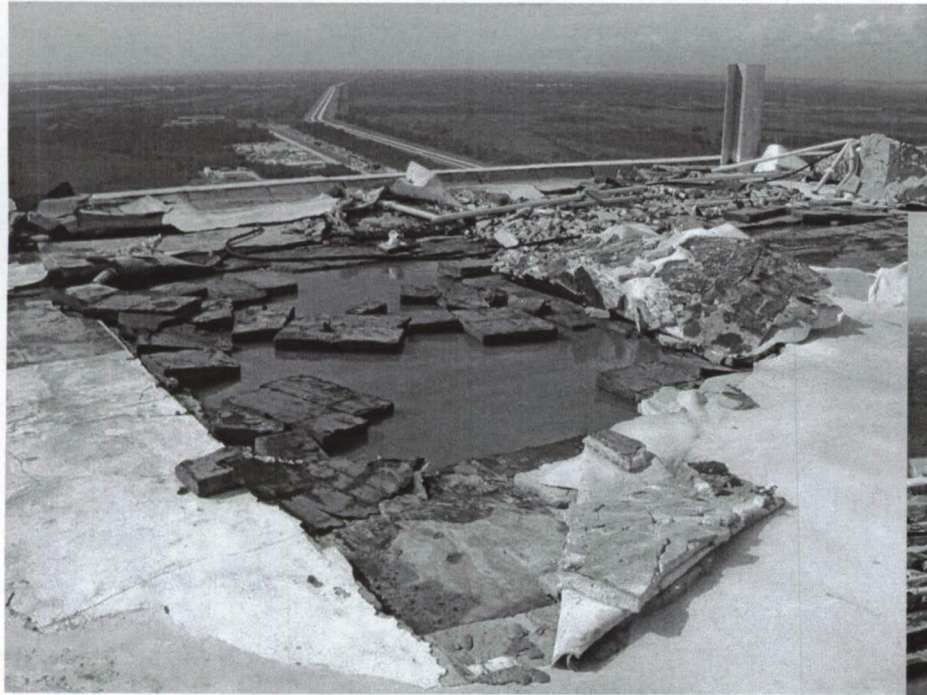
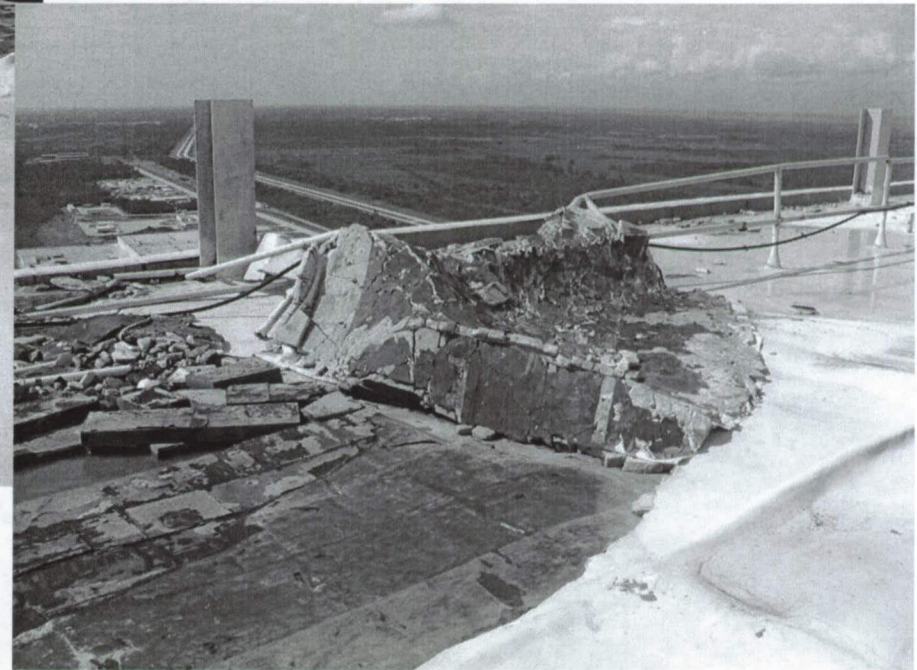
LC39 Area:

Vehicle Assembly Building (VAB) (K6-0848) – exterior roof damage

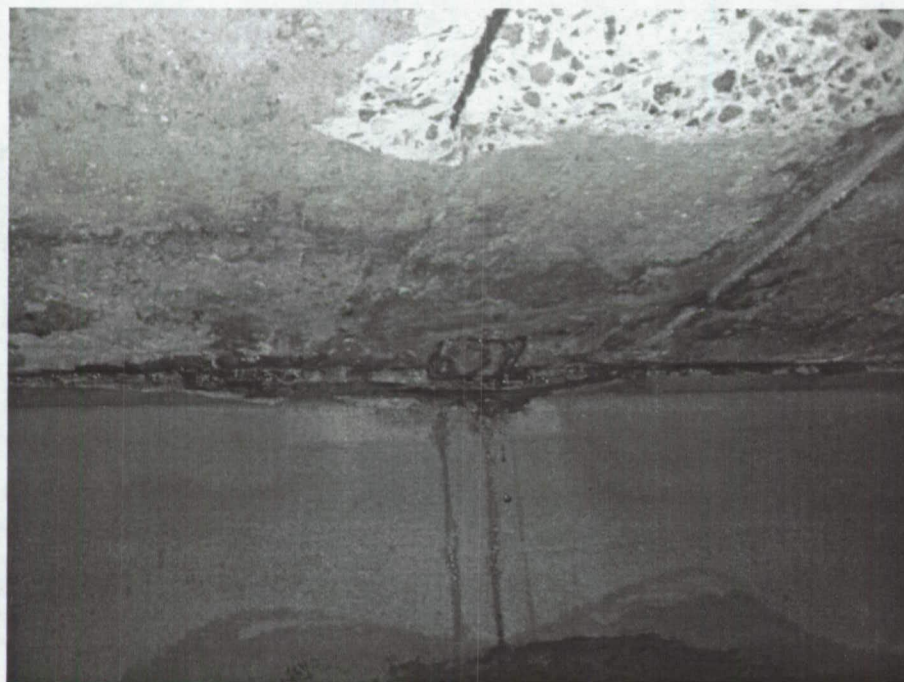
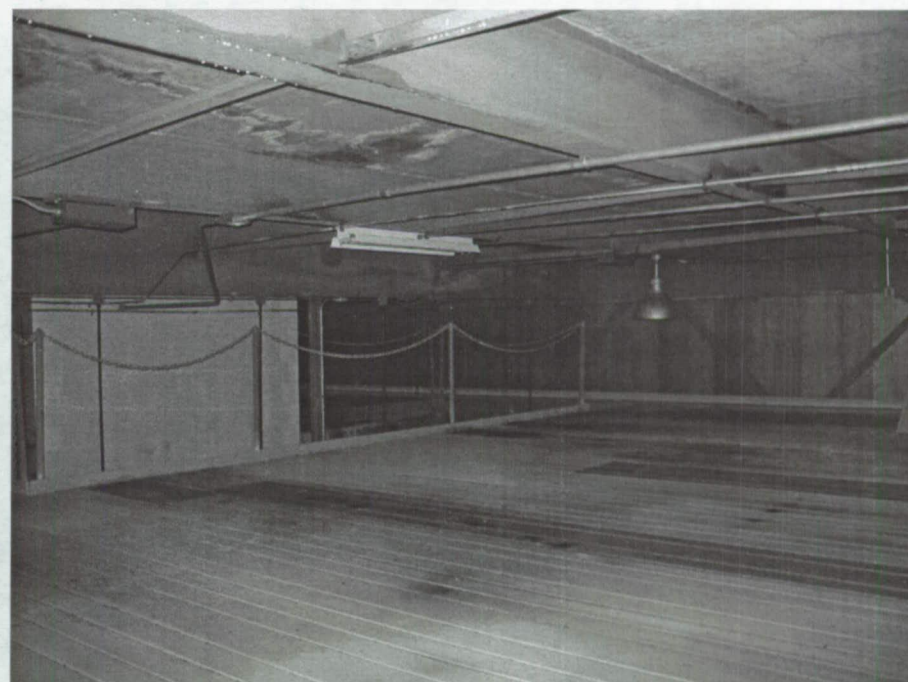
LC39 Area:

Vehicle Assembly Building (VAB) (K6-0848) – interior roof damage

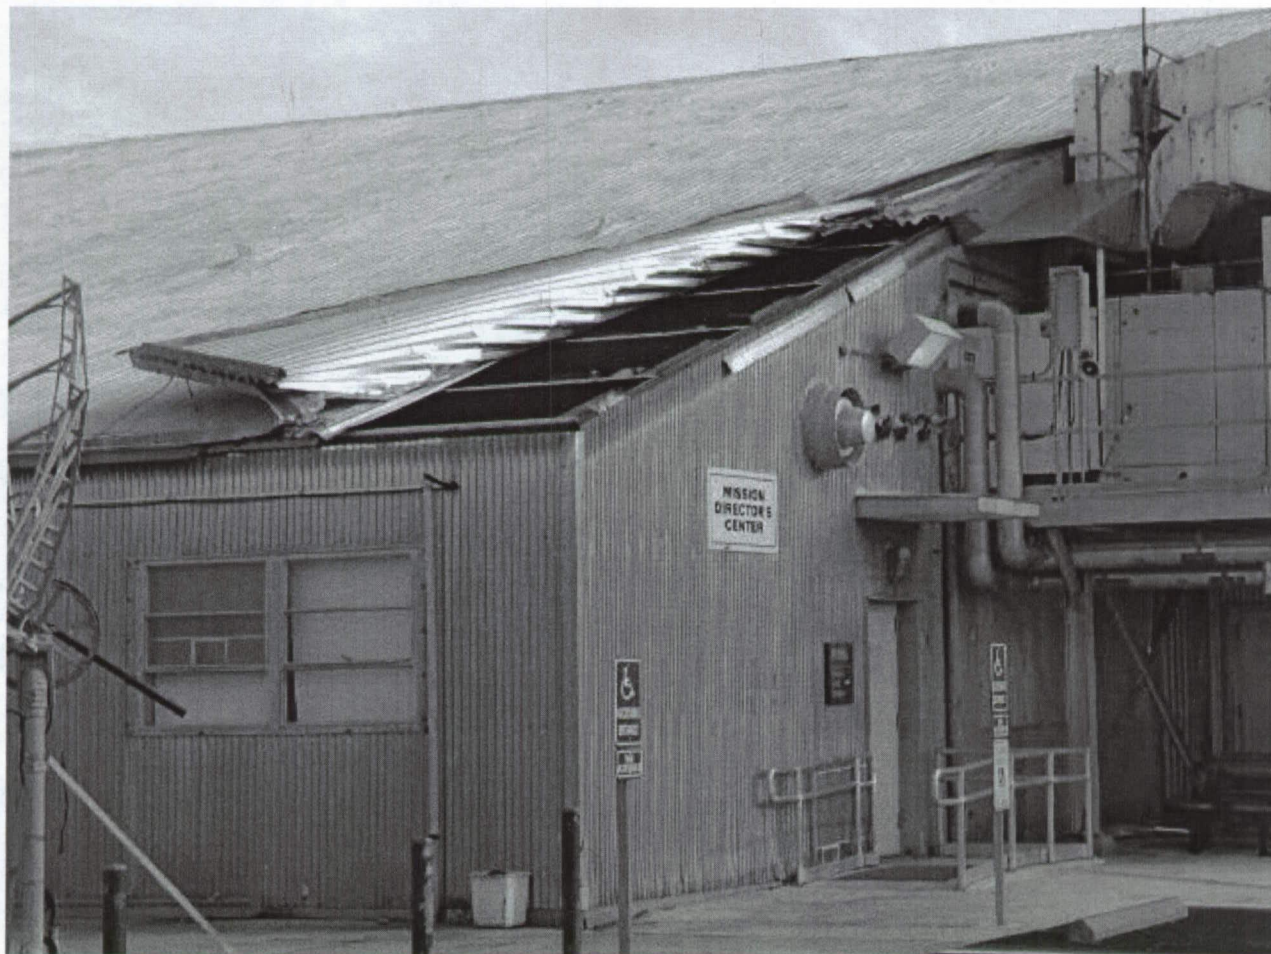
NASA facilities on Cape Canaveral Air Force Station
Hangar AE (60680) – SE corner exterior

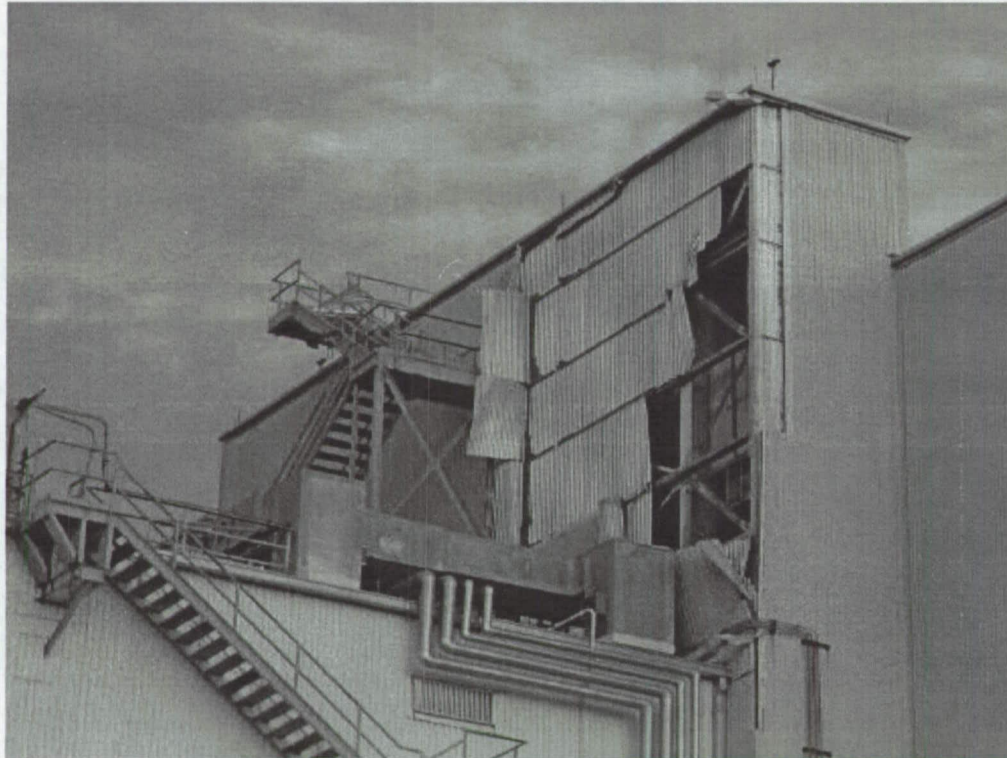
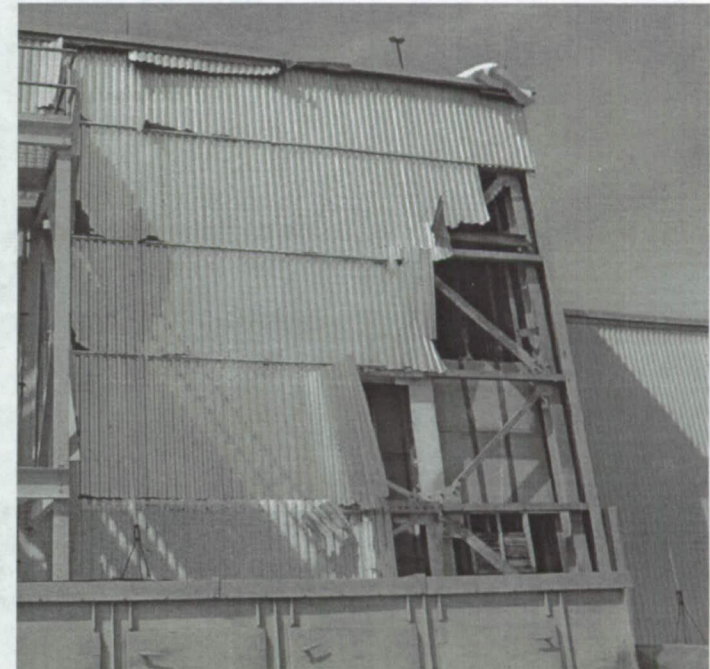
KSC Industrial Area

Vertical Processing Facility (VPF) (M7-1469) – Side panel damage south side

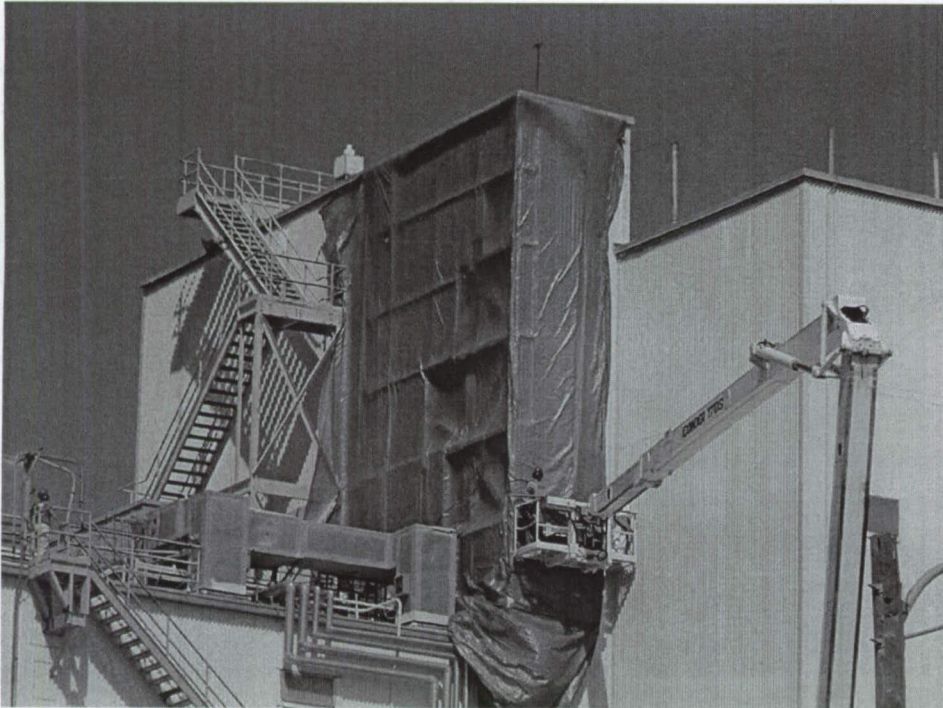
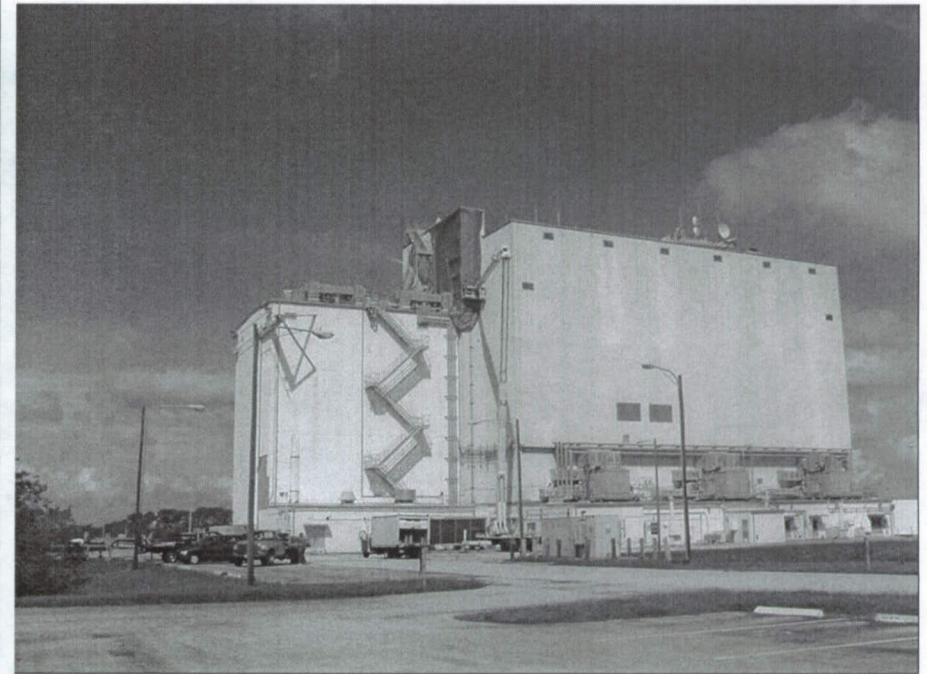
KSC Industrial Area

Vertical Processing Facility (M7-1469) – tarps cover panel damage

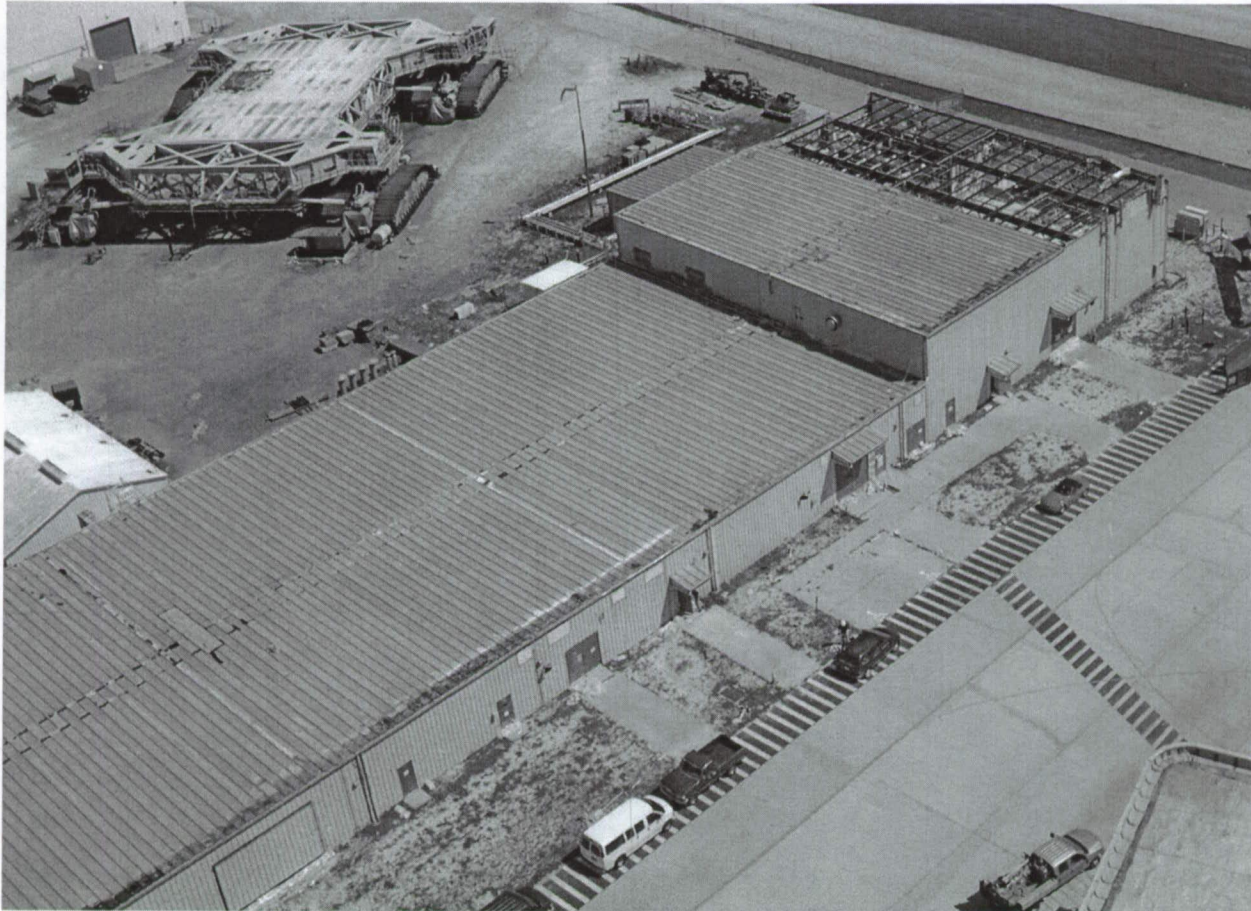
Launch Complex 39 Area

Thermal Protection System Facility (TPSF) (K6-0744) – extensive roof damage on 2nd floor east end of facility

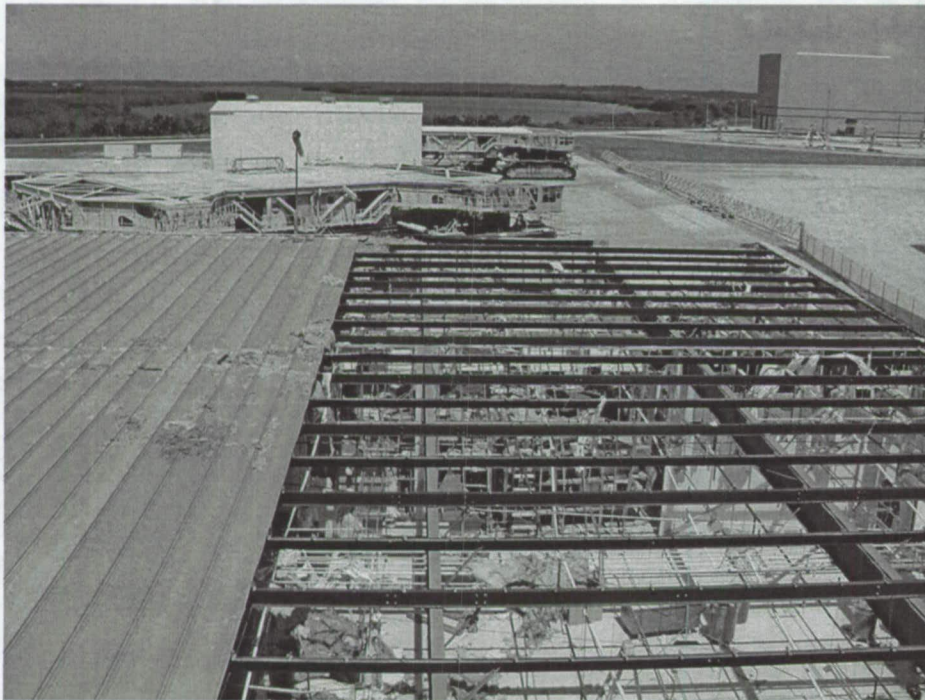
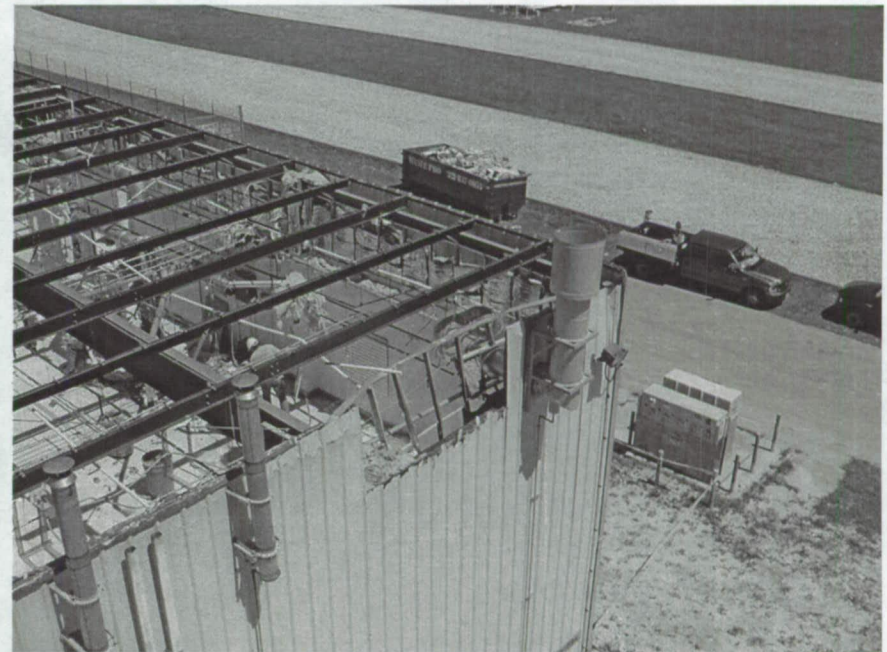
Launch Complex 39 Area
Thermal Protection System Facility (TPSF) (K6-0744) – extensive
roof damage on 2nd floor east end of facility

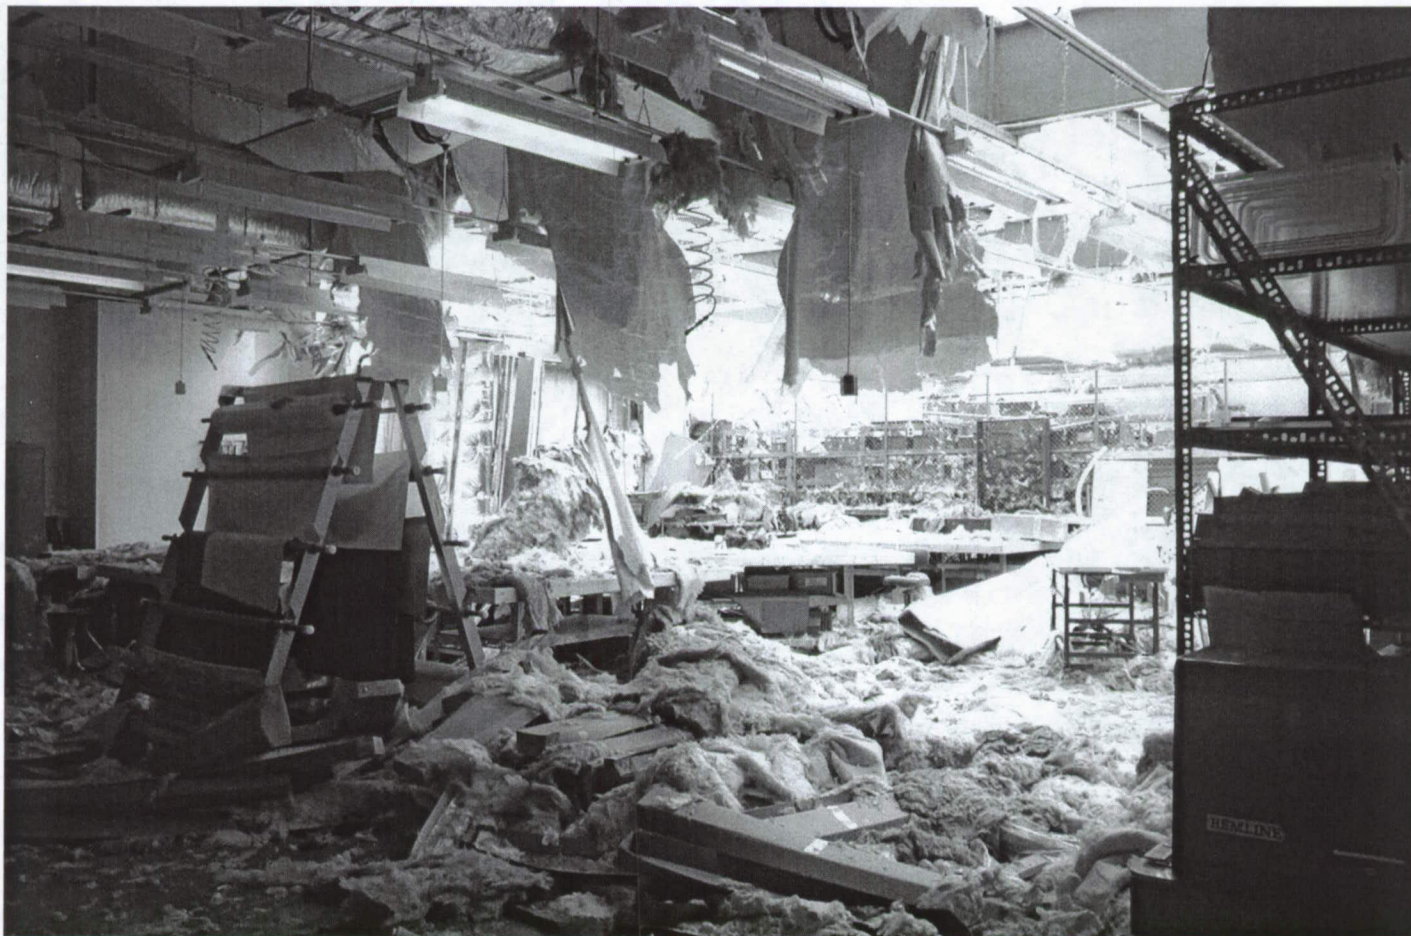
Launch Complex 39 Area

Thermal Protection System Facility (TPSF) (K6-0744) – interior damage
– 2nd floor soft goods area

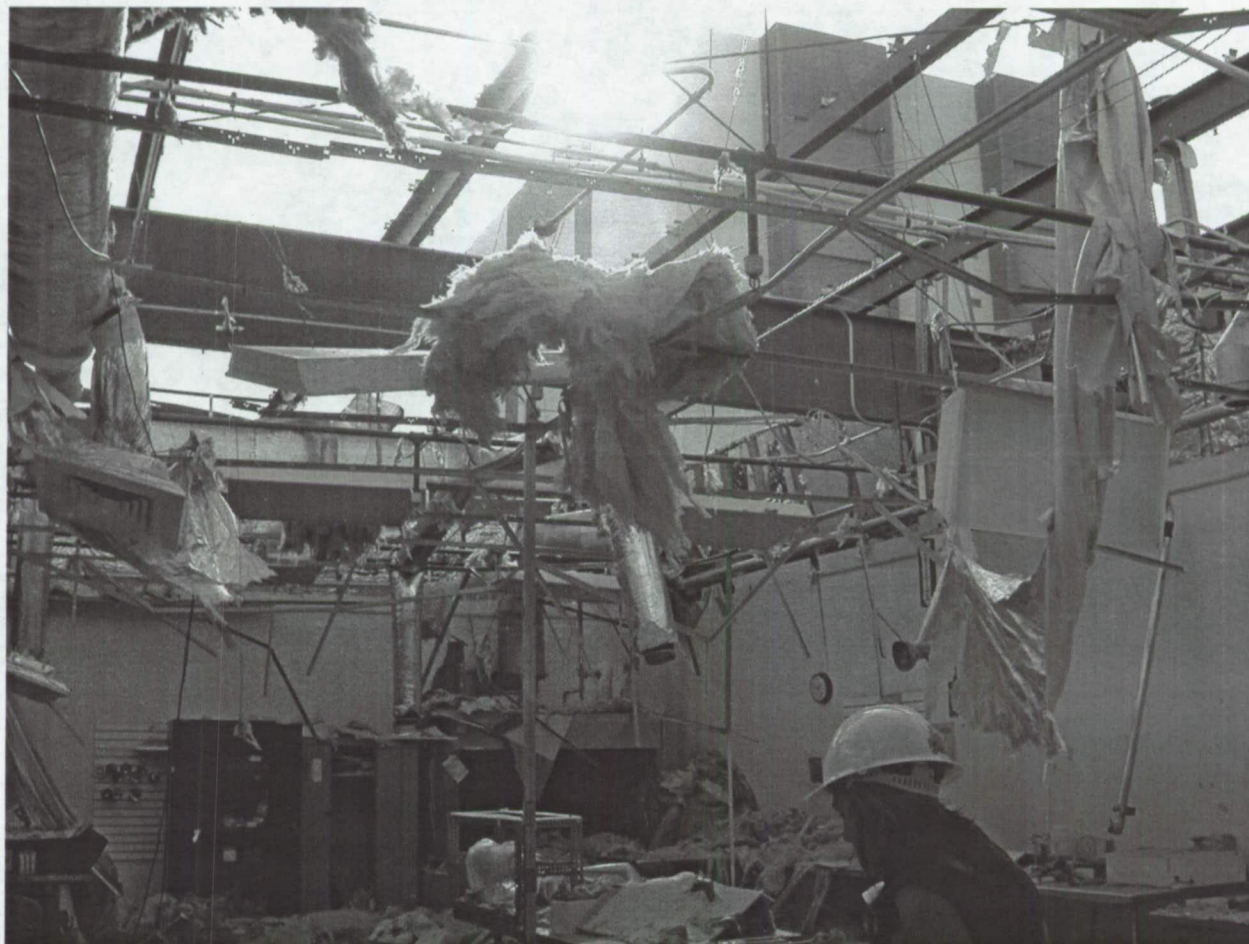
Launch Complex 39 Area

Thermal Protection System Facility (TPSF) (K6-0744) – interior damage

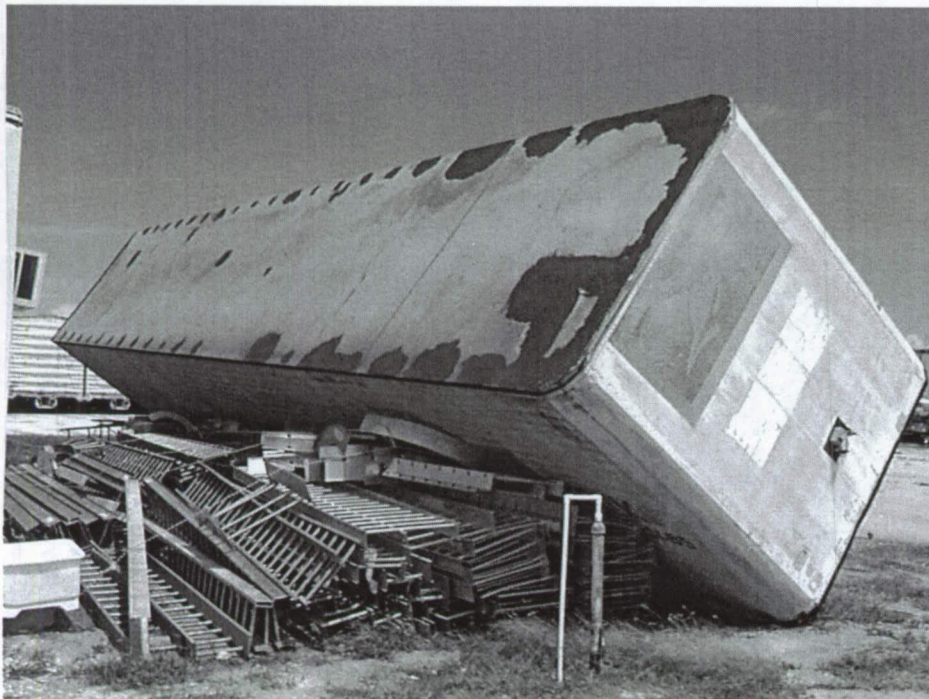
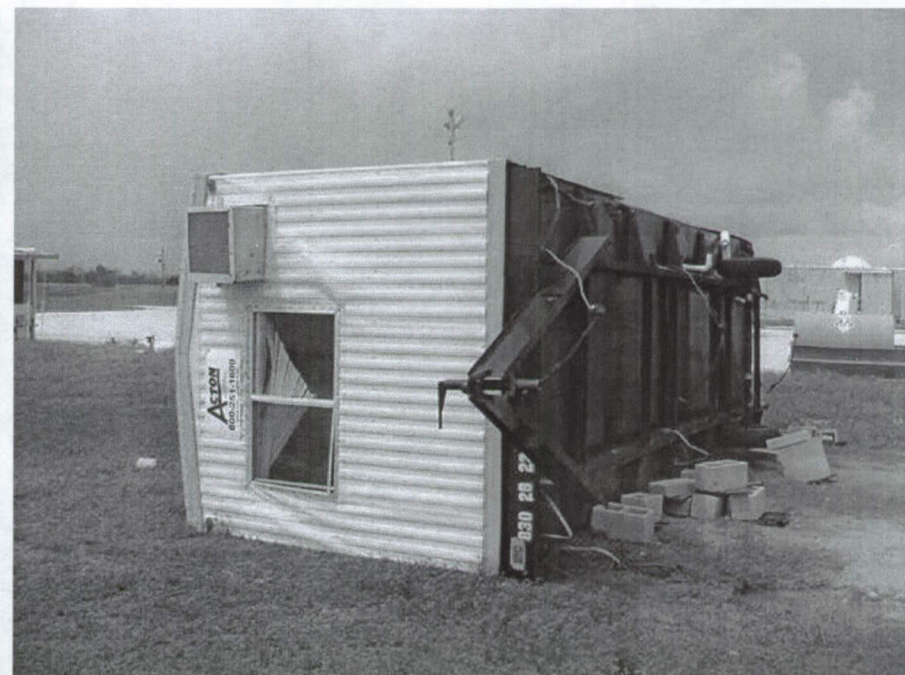
Trailers at various construction sites overturned

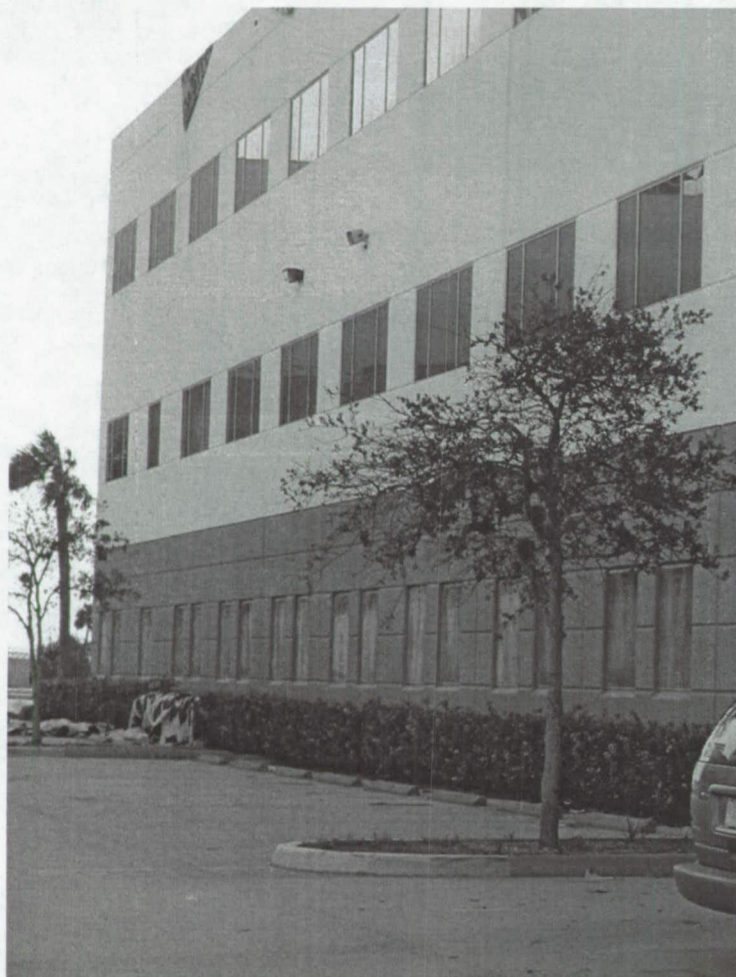
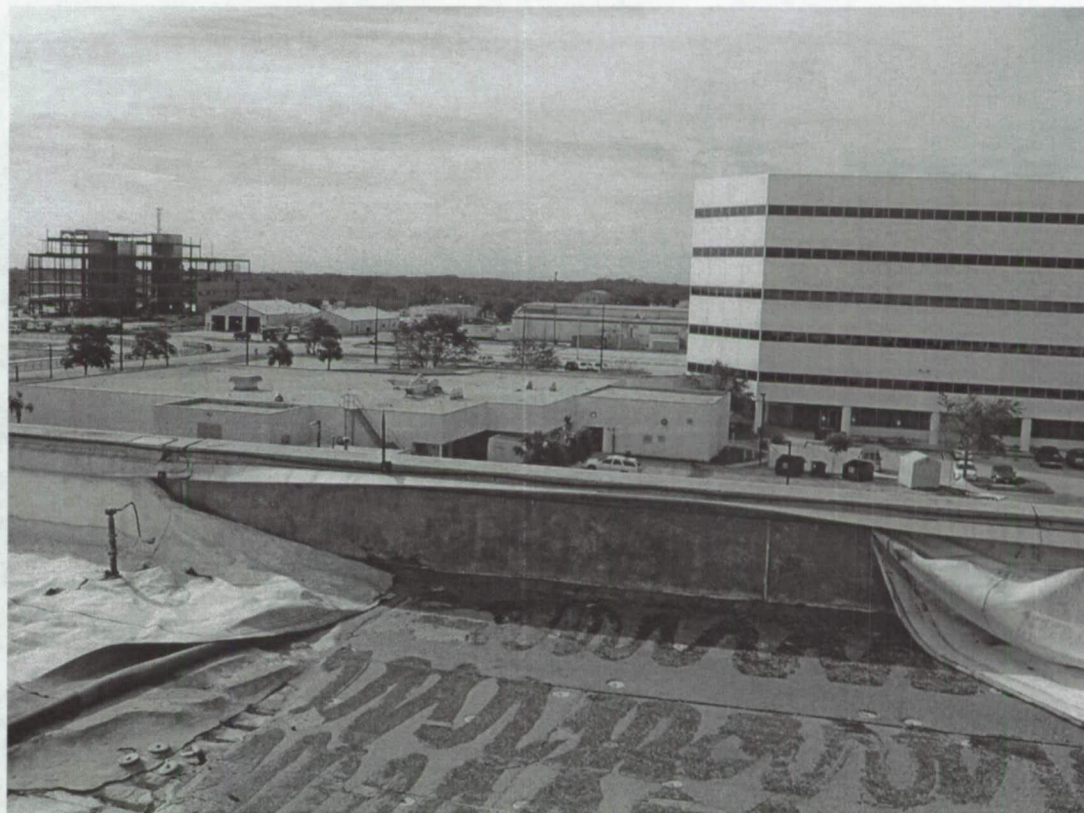
Launch Complex 39 Area
Processing Control Center (PCC) (K6-1094) – exterior roof damage (roof
on ground in left photo)

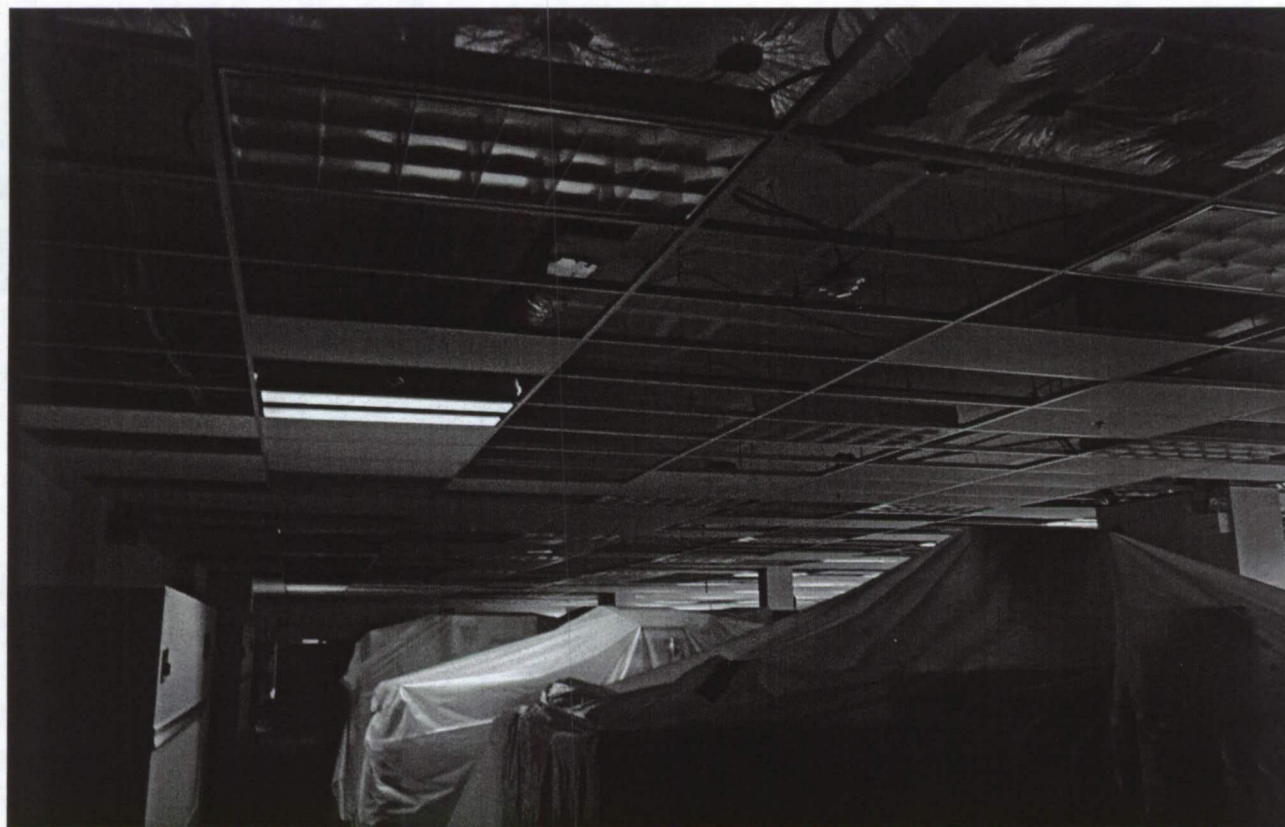
Launch Complex 39 Area
Processing Control Center (PCC) (K6-1094) – interior damage

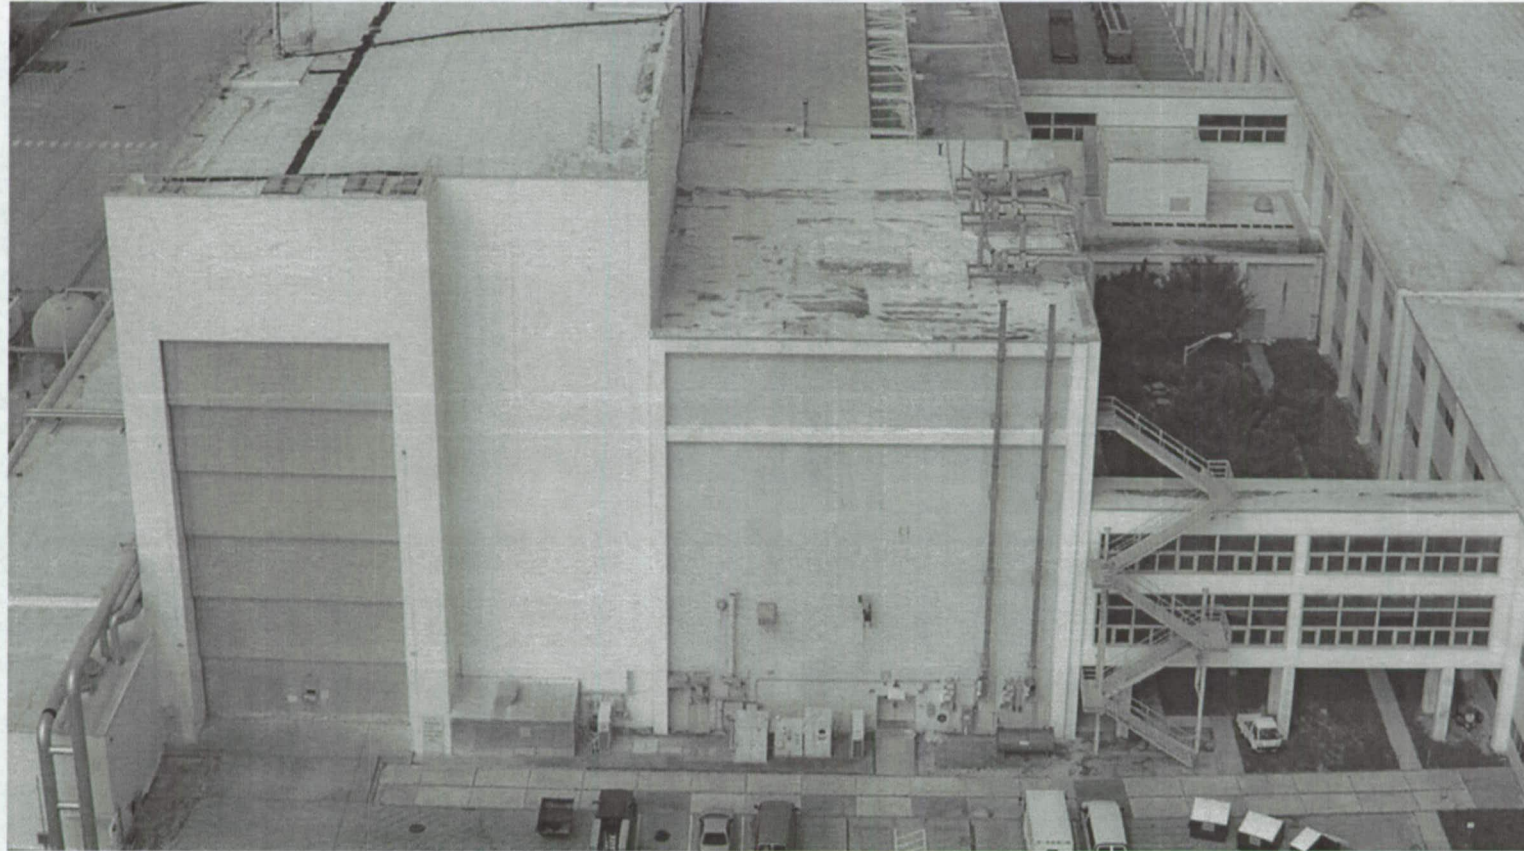
KSC Industrial Area

Operations and Checkout (O&C) Building (M7-0355) – initial exterior roof damage east end high bay and 5th floor (covered with visqueen)

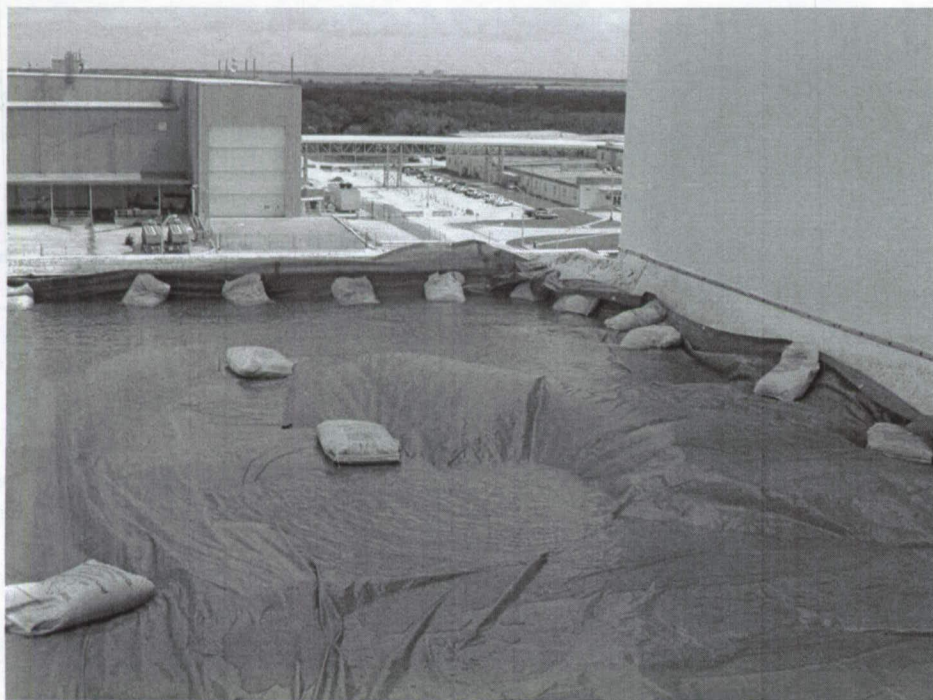
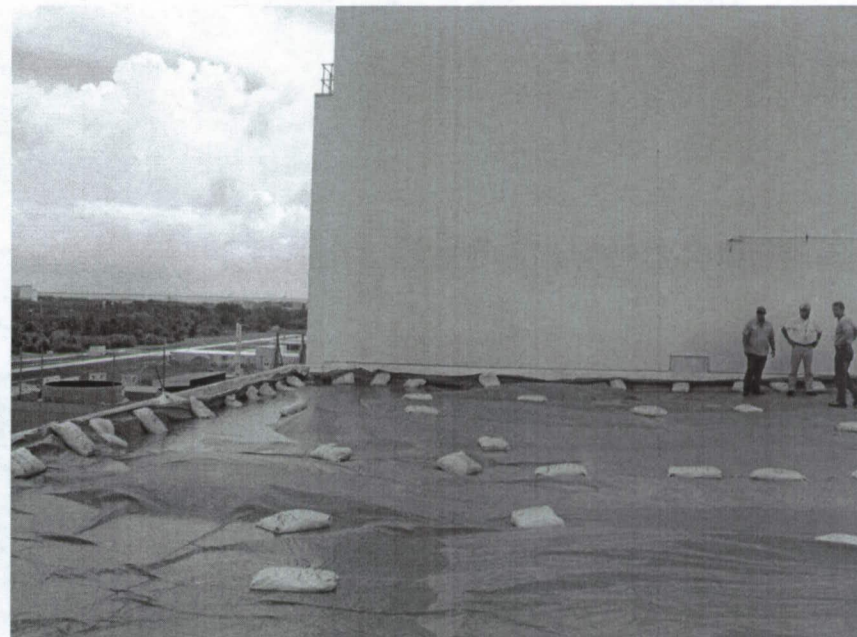
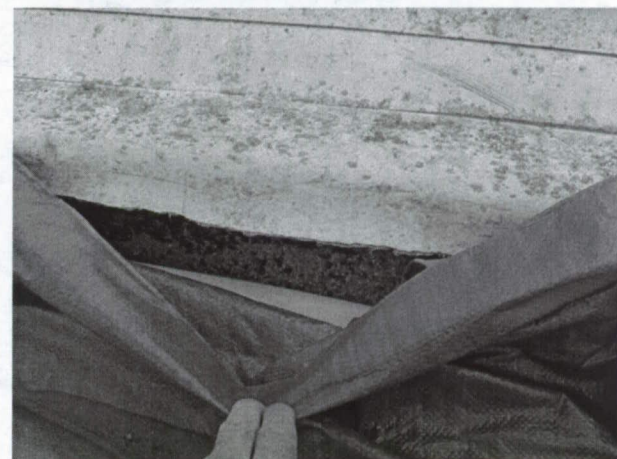
KSC Industrial Area

Operations and Checkout (O&C) Building (M7-0355)
– tarps cover roof on east end
